Project Data

Location	New York
Completed	2005
Project Type	Timber Pile Rehabilitation
Products / Systems Used	Denso Fiber-forms

Project Details

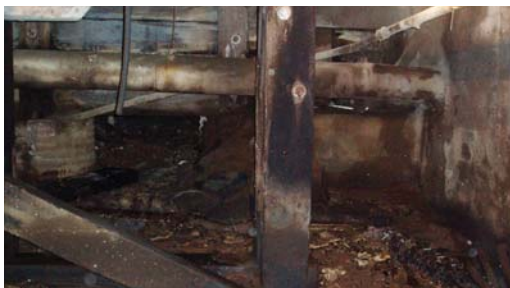
The unprotected timber piles that received marine borer damages.

In service for over 95 years, the timber piles had received marine borer damage, which threatened the structural integrity of the slips. The pile repair system chosen was concrete encapsulation with rebar and fiberglass forms. This major rehabilitation called for more than 5,000 linear feet of timber pile repair with Denso Fiber-Forms. The fiberglass forms provide a strong rigid form to allow concrete to be pumped into the annulus space between the jacket and timber pile.

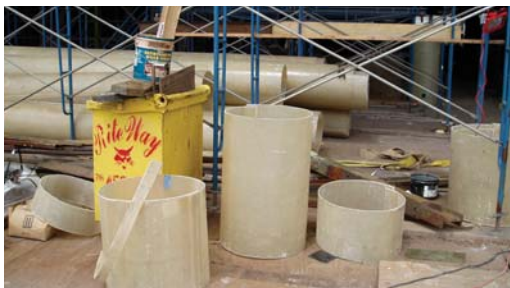
Uninstalled SeaShield Fiber-Forms being prepped and awaiting install.

Denso's Fiber-Forms used for the Battery Maritime Building were custom fabricated to 3/16" thick utilizing woven-roven construction. Installation included installing a reinforcement cage around the piles and then installing the fiberglass forms. The concrete was then pumped into the annulus space and to provide ease of application the forms were fabricated in a translucent color to allow the contractor to view the concrete level during the pumping operation. The complete repair will provide years of maintenance free structural integrity to the timber piles.

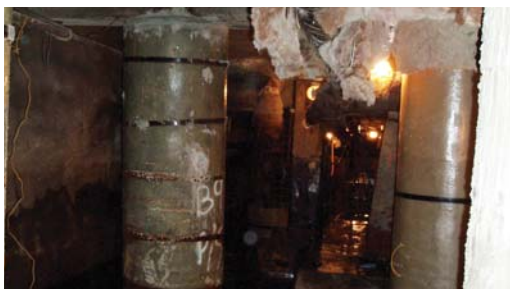
Completed Denso Fiber-Forms installation to the timber piles.
