CASE STUDY | Bending Tests of Repaired Marine Timber Piles

» INTRODUCTION

» TEST SPECIMENS

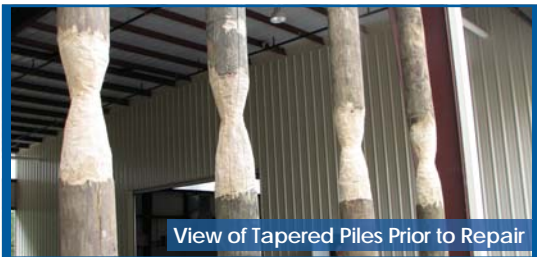
View of Tapered Piles Prior to Repair

Six timber piles were used in the test program as summarized in Table 1. All piles were 16' long, approximately 8" diameter, and of treated southern pine. To simulate marine damage, five of the piles had an hourglass-shaped taper cut into them at mid-span (four of the tapered piles are shown above prior to

repair). One pile (Pile #0) was used as the line base specimen and was undamaged.

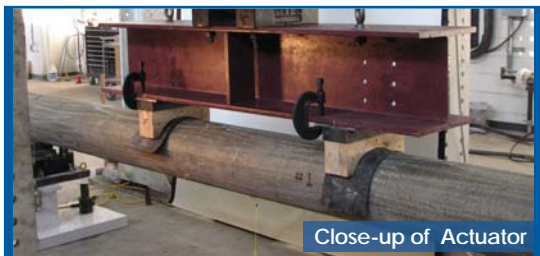
Close-up of Actuator

A single 220,000 lbs. capacity actuator was used to apply the load. While the capacity of this actuator exceeded the expected max bending capacity of the pile specimens, it provided a max stroke of 30". The actuator was operated with a MTS FlexSystem-60 controller. The actuator was operated under load-control with a constant load rate of 250 lbs. per second. A spreader beam was used to evenly apply the load to the specimens, four feet apart. Wooden support saddles, made up three 2 x 8 dimension lumber, were used at the supports and the load points. This gave a bearing length of 4½". The saddles had cut-outs that matched the radii of the pile specimens. Neoprene pads, ¼" thick, were used between the saddles and pile specimens

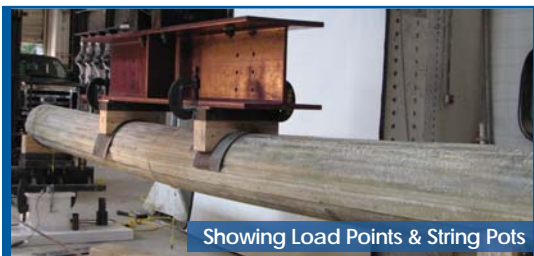
Showing Load Points & String Pots

The displacement of the actuator was measured using the actuator's built-in linear voltage displacement transducer (LVDT). However, this over-estimated the mid-span deflection of the specimens due to the flexibility at the supports and the load points. Therefore, linear string pots, located at the end supports and

at mid-span, were used to provide a more accurate measure of the mid-span deflection. The average of the end deflections was subtracted from the mid-span deflection, as measured by the string pots.

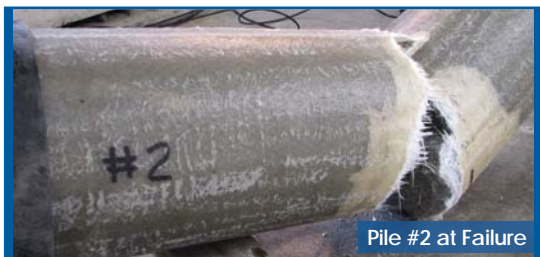
Pile #2 at Failure

The results of the six pile bending tests are summarized in Graph 1 & 2. In general, all repaired piles exceeded the bending strength of the baseline pile (Pile #0) by at least double the maximum load achieved by the baseline pile (9,050 pounds). Above left image provides a view of Pipe #2 at failure.

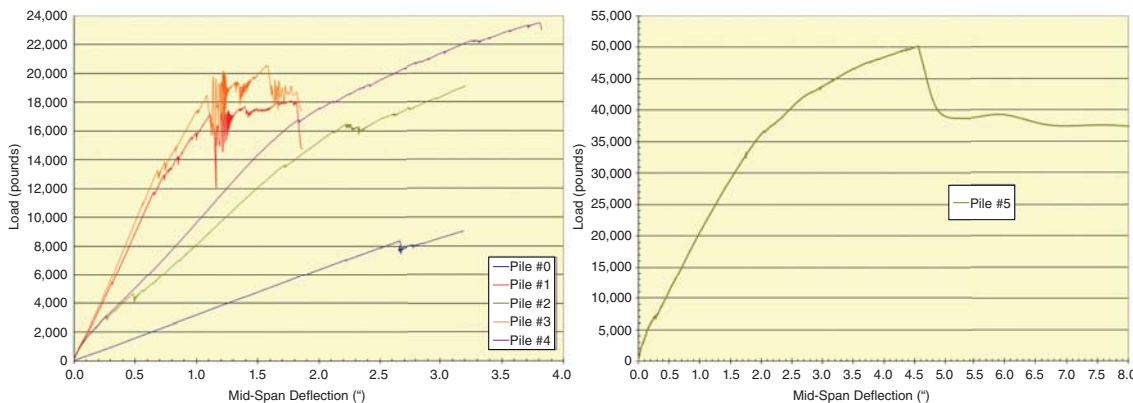
PLOT OF LOAD VERSUS DEFLECTION
