### Project Data

Location	Houston, TX
Completion	October 2014
Project Type	Cooling Tower Protection
Products Used	Densyl Tape / Denso Hi-Tack Tape / Denso Paste
Contractor or Applied By	Maintenance Personnel

### Project Details

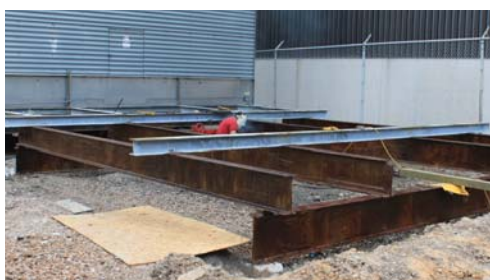
The maintenance crew completing the wrap protection system to the cooling tower frame work.

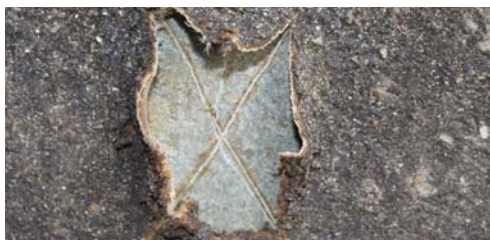
Inspection of the I-Beam, with Densyl Tape protecting since 1977, revealed the surface underneath to be in excellent condition with no corrosion.

In 1977 American General applied the Denso Petrolatum System to protect their cooling tower framework and piping. After years of service the cooling towers had to be replaced. This provided the perfect opportunity to inspect Denso's Petrolatum Tape System. The petrolatum tape coating had been in service for over 37 years in a wet/humid corrosive environment. It was found after removing the Denso Petrolatum Tape, the steel was in perfect condition with no corrosion. Since the coating system exceeded the life of the cooling tower the engineers specified that all pipes, valves, fittings and structural steel be protected with the Denso Petrolatum Tape System. Denso has a long list of successful case histories as we have been manufacturing petrolatum products for over 85 years.
