CASE STUDY

AMERICAN GENERAL BUILDING

Cooling Tower Protection

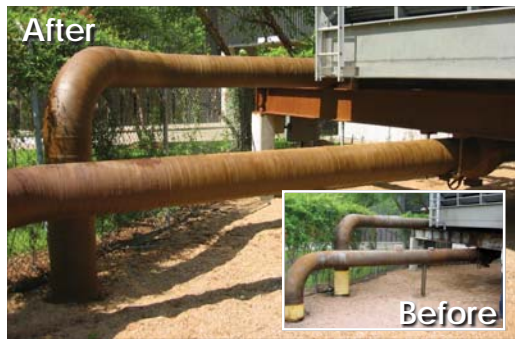
Denso Tape Applied in 1977

Denso's Petrolatum Tape System has provided external corrosion protection for over 35 years on the exposed piping at the American General Building in Houston, TX. After the original paint coating failed within a few years of operation, the Denso Petrolatum Tape System was applied in 1977 and is still providing excellent corrosion protection. The original cooling tower is being replaced with a new tower that is more efficient. An inspection of the pipe revealed the surface underneath the tape to be in excellent condition with no corrosion. Thus, the tape system exceeded the life of the cooling tower that it was applied to. Due to the longevity of the Denso product, the engineers specified the Denso Petrolatum Tape System to protect all the piping, H-beams and valves on the new cooling tower. The Denso Petrolatum Tape System consists of petrolatum based primer and tape. The tape is composed of a non-woven synthetic fabric carrier that is impregnated with a petrolatum compound and inert siliceous fillers. Denso Petrolatum Tape has protected millions of square feet of steel in a variety of highly corrosive environments.

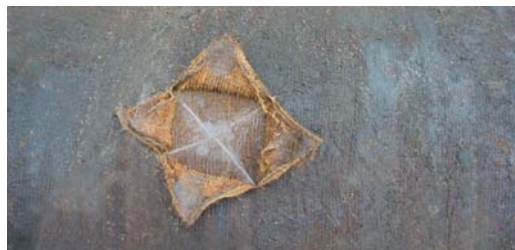
An inspection of the pipe revealed the surface underneath the tape to be in excellent condition with no corrosion.
