### Project Data

Location	South Texas
Est. Completion	2013
Project Type	Open Top / Internal Floaters
Products / Systems Used	Archco Linings System

### Project Details

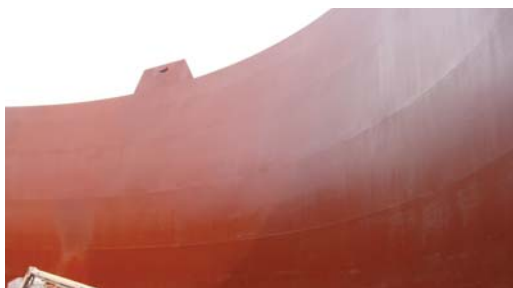
Open top tank, side walls primed with 400.

The project consisted of two open top/internal floater tanks with the sidewalls coated with Archco 400 high solids epoxy primer and then over coated with Archco 450, 100 % solids epoxy, glass flaked filled lining. All coatings were sprayed with a 68:1 single leg airless unit. The Archco 450 was sprayed at 25 to 30 mils in one coat. The coating was applied prior to the insulation of a new internal floating roof. The Archco 450 will give the tank the chemical resistance, plus the added benefit of the glass flaked filled lining to withstand the abrasion of the floating roof seal, rubbing up and down, as the tank is filled and emptied. The tank floor linings will be installed after the insulation of the floating roof using the Archco 450. The owners can expect 25+ years of internal corrosion protection from the Denso Archco Lining System.

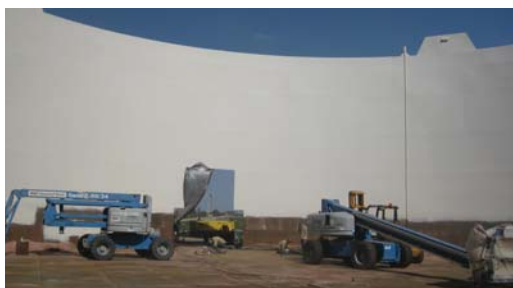
Open top tank, side was coated with 400 and 450 gray.

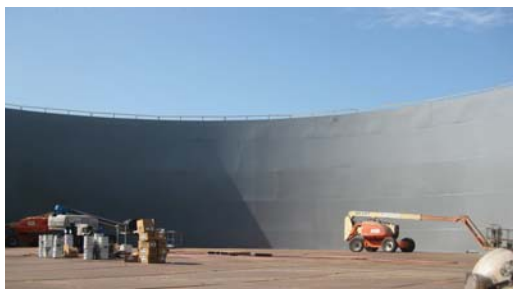
Open top tank, side was coated with 400 and 450 gray.
