Project Data

Location	South Texas
Est. Completion	2013
Project Type	Open Top / Internal Floaters
Products / Systems Used	Archco Linings System

Project Details

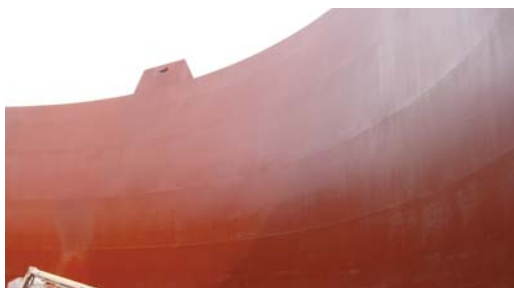
Open top tank, side walls primed with 400.

The project consisted of two open top/internal floater tanks with the sidewalls coated with Archco 400 high solids epoxy primer and then over coated with Archco 450, 100 % solids epoxy, glass flaked filled lining. All coatings were sprayed with a 68:1 single leg airless unit. The Archco 450 was sprayed at 25 to 30 mils in one coat. The coating was applied prior to the insulation of a new internal floating roof. The Archco 450 will give the tank the chemical resistance, plus the added benefit of the glass flaked filled lining to withstand the abrasion of the floating roof seal, rubbing up and down, as the tank is filled and emptied. The tank floor linings will be installed after the insulation of the floating roof using the Archco 450. The owners can expect 25+ years of internal corrosion protection from the Denso Archco Lining System.

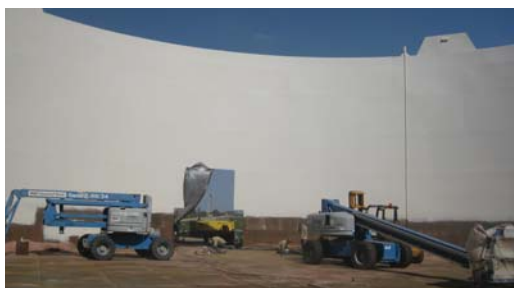
Open top tank, side was coated with 400 and 450 gray.

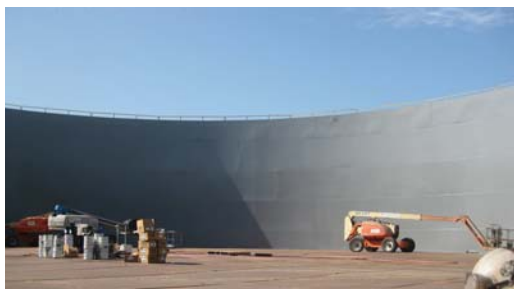
Open top tank, side was coated with 400 and 450 gray.
