CASE STUDY

DENVER AIRPORT

Valve and Meter Protection

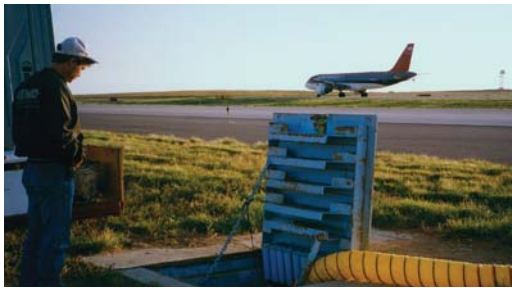
One of the 204 vaults in close proximity to the airport runway.

Soon after opening, Denver Water became aware of a potential problem with over 200 of their meter and control stations located throughout the airport area. Most of these stations are located below ground in concrete vaults close to the runways, taxiways and aprons. The watertight seals on the vault lids failed after the first year of installation. De-icing procedures allowed salt, water and a small percentage of glycol to drain into these vaults which accelerated the corrosion process on the meters and valves.

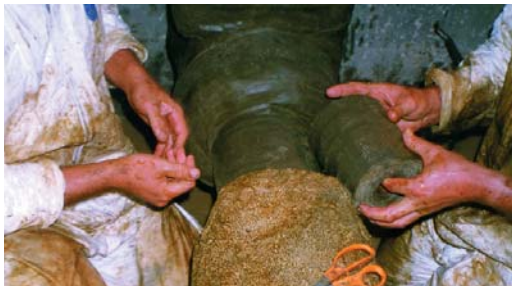
Densyl Tape is applied over the smooth contours of the Denso Profiling Mastic.

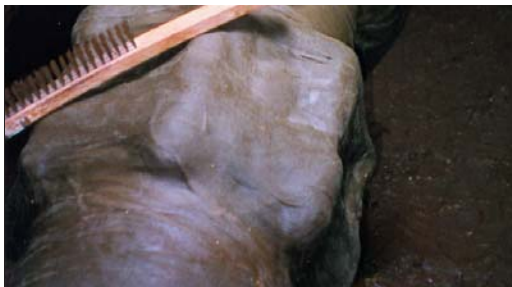
Completed application of one many valves and meters with Denso Petrolatum Tape System.

The system comprising Denso Paste, Denso Profiling Mastic and Densyl Tape was evaluated over a one-year period and then was specified to coat 204 vaults at the airport. Bids for the project were under budget across the board. The awarded contractor used almost 200 cases of Densyl Tape in various sizes and almost 1000 cases of Denso Profiling Mastic.
