Location	New York
Completed	2005
Project Type	Timber Pile Rehabilitation
Products / Systems Used	Denso Fiber-forms

New York's Battery Maritime Building received a \$58 million renovation in which Denso's SeaShield Fiber-Forms were used to rehabilitate the timber piles supporting the slips. The building is listed on the National Register of Historic Places built in 1909 in the "Iron Age" with vaulted arches and ornamental structures steel. The building has over 140,000 square-feet and offers rare waterfront views of Manhattan and The Statue of Liberty.

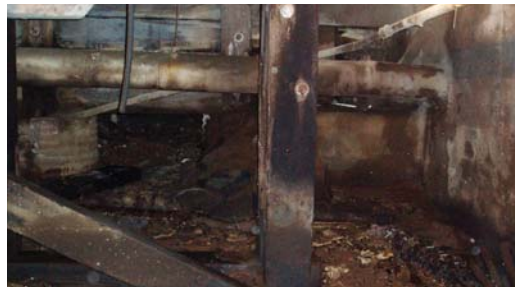
The unprotected timber piles that received marine borer damages.

In service for over 95 years, the timber piles had received marine borer damage, which threatened the structural integrity of the slips. The pile repair system chosen was concrete encapsulation with rebar and fiberglass forms. This major rehabilitation called for more than 5,000 linear feet of timber pile repair with Denso Fiber-Forms. The fiberglass forms provide a strong rigid form to allow concrete to be pumped into the annulus space between the jacket and timber pile.

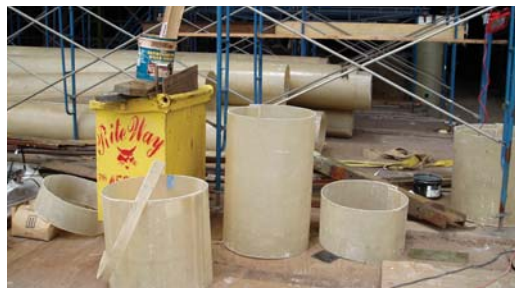
Uninstalled SeaShield Fiber-Forms being prepped and awaiting install.

Denso's Fiber-Forms used for the Battery Maritime Building were custom fabricated to 3/16" thick utilizing woven-roven construction. Installation included installing a reinforcement cage around the piles and then installing the fiberglass forms. The concrete was then pumped into the annulus space and to provide ease of application the forms were fabricated in a translucent color to allow the contractor to view the concrete level during the pumping operation. The complete repair will provide years of maintenance free structural integrity to the timber piles.

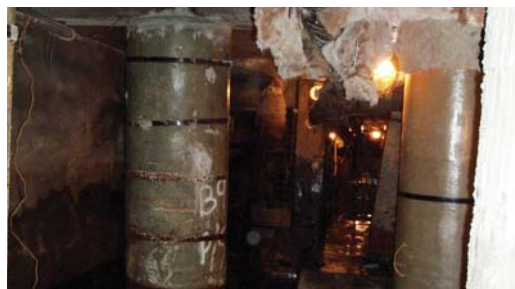
Completed Denso Fiber-Forms installation to the timber piles.
