Project Data

Location	New York
Completed	2005
Project Type	Timber Pile Rehabilitation
Products / Systems Used	Denso Fiber-forms

Project Details

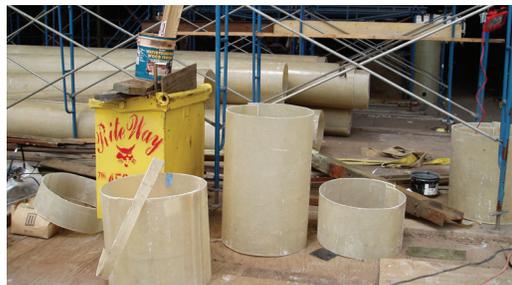
Uninstalled SeaShield™ Fiber-Forms being prepped and awaiting install.

Denso's Fiber-Forms used for the Battery Maritime Building were custom fabricated to 3/16" thick utilizing woven-roven construction. Installation included installing a reinforcement cage around the piles and then installing the fiberglass forms. The concrete was then pumped into the annulus space and to provide ease of application the forms were fabricated in a translucent color to allow the contractor to view the concrete level during the pumping operation. The complete repair will provide years of maintenance free structural integrity to the timber piles.

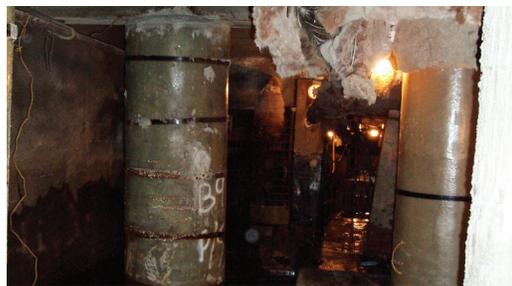
Completed Denso Fiber-Forms installation to the timber piles.
