CASE STUDY

CITY OF TORONTO

Sanitary Chamber Joint Sealing

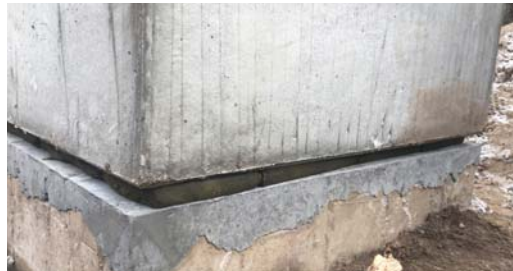
Densyl Mastic is laid upon the prepared surface in preparation for the box chamber.

Densyl Mastic was chosen due to its density as the best product to ensure a strong, water-tight seal between the mortar and new section of chamber. After the Densyl Mastic was laid, the box chamber was lowered on top. The exterior was then coated with a thin, uniform layer of Denso Hi-Tack Primer which was allowed to sit, giving time for the thinning agent to evaporate. After a few minutes, Denso Hi-Tack Tape 12" was wrapped around the joint starting 6" below and wrapping upwards with a 50% overlap. The tape was firmly pressed down to ensure intimate contact and adhesion to the surface and the area was backfilled.

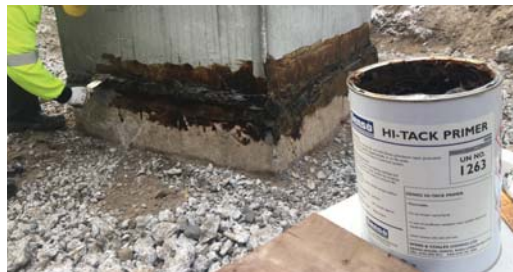
With the chamber in place, Hi-Tack Primer is applied in thin uniform coating.

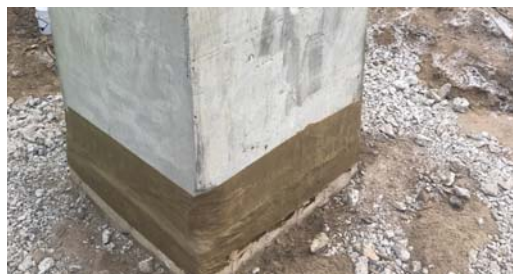
Hi-Tack Tape is applied 6" below to 6" above the joint and will provide a permanent flexible water-tight seal.
