# CASE STUDY

CITY OF TORONTO

Sanitary Chamber Joint Sealing

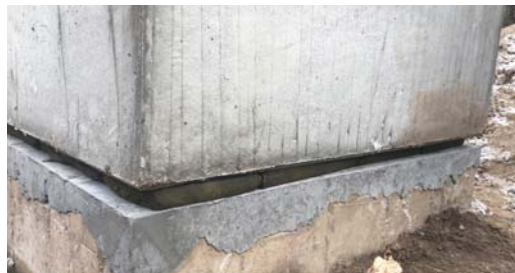
Densyl Mastic is laid upon the prepared surface in preparation for the box chamber.

Densyl Mastic was chosen due to its density as the best product to ensure a strong, water-tight seal between the mortar and new section of chamber. After the Densyl Mastic was laid, the box chamber was lowered on top. The exterior was then coated with a thin, uniform layer of Denso Hi-Tack Primer which was allowed to sit, giving time for the thinning agent to evaporate. After a few minutes, Denso Hi-Tack Tape 12" was wrapped around the joint starting 6" below and wrapping upwards with a 50% overlap. The tape was firmly pressed down to ensure intimate contact and adhesion to the surface and the area was backfilled.

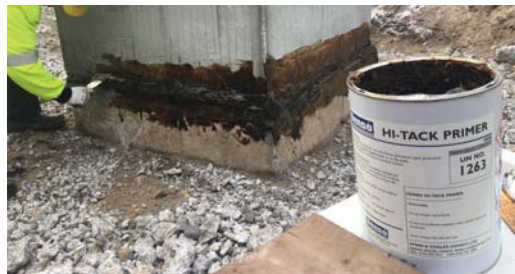
With the chamber in place, Hi-Tack Primer is applied in thin uniform coating.

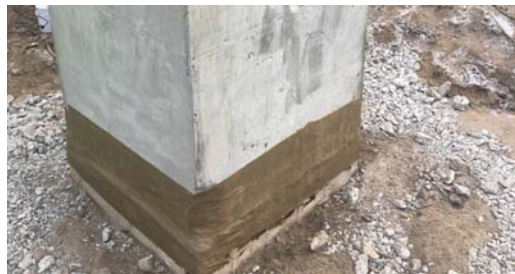
Hi-Tack Tape is applied 6" below to 6" above the joint and will provide a permanent flexible water-tight seal.
