CASE STUDY

CITY OF BARRIE

Proactive Road Joint Sealing

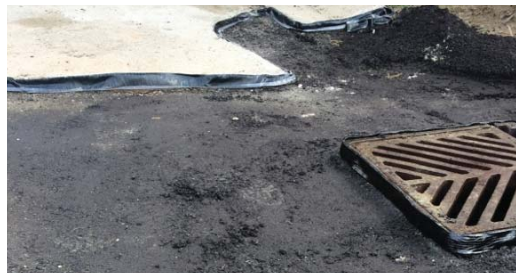
Applied in minutes to minimally prepared surfaces.

Concerned with disbondment of asphalt cold joints, the road supervisors started having workers install Denso Reinstatement Tape on the internal perimeter of utility cuts after base asphalt and prior to top lift installation.

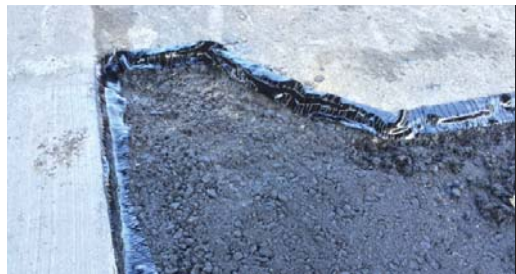
The Reinstatement Tape contours irregular shaped joints and is applied to asphalt, steel and concrete.

Denso Reinstatement Tape is a modified polymer bitumen strip which will compress and rebound keeping water out of joints where asphalt meets asphalt, steel and concrete.

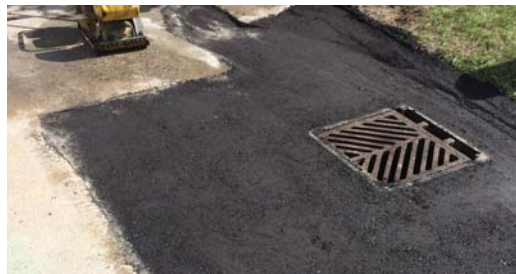
The joint is now protected from damage by water and ice for decades to come.

Over a decade of freeze and thaw cycles, the joints pictured here have stayed intact. Dunlop Street, a very busy street that runs the length of downtown Barrie, has seen it's share of traffic, construction and infrastructure repair and still, the joints protected with Denso Reinstatement Tape remain closed, water tight and without cracks.
