### Project Data

<b>Location</b>	Canada
<b>Est. Completion</b>	2017
<b>Project Type</b>	Pipeline RTD Sensor Corrosion Protection
<b>Products Used</b>	Protal™ 7200 (Protal 7250 in Canada) / Denso® Paste HT / Densyl Mastic / Denso Hotline Tape / Denso Glass Outerwrap

### Project Details

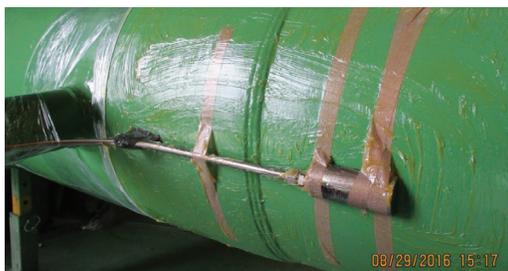
RTD Sensor attached to Protal 7200 coated pipe and a thin layer of Denso Paste HT coating the sensor.

The RTD sensor was then attached to the surface of the pipe. The entire area was then coated with a thin layer for Denso Paste HT. Then the RTD is encapsulated with a layer of Densyl Mastic. This would assure there were not any voids or cavities left around the RTD. Denso Hotline Tape was then applied with a 55% overlap around the entire circumference of the pipe. This would ensure the long term sealing of the area around the RTD. The entire area was then wrapped with Denso Glass Outerwrap to give mechanical protection to the entire assembly. The entire valve assemblies were then ready to be shipped to site for final installation.

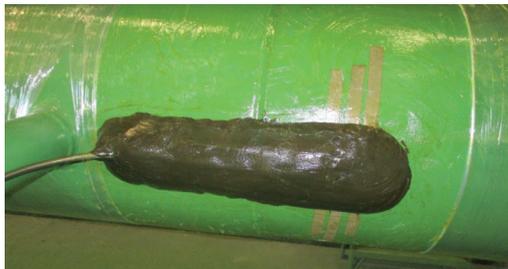
The RTD Sensor is encapsulated within Densyl Mastic.

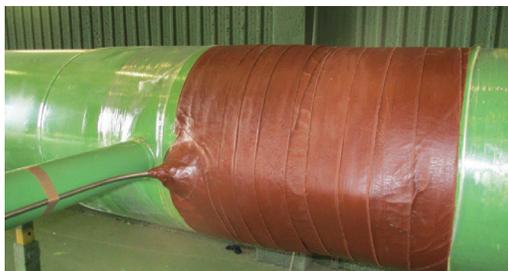
55% overlap of Denso Hotline Tape around the sensor to provide corrosion protection prior to being buried.
