CASE STUDY

TEXAS A&M TESTING

Timber Pile Rehabilitation

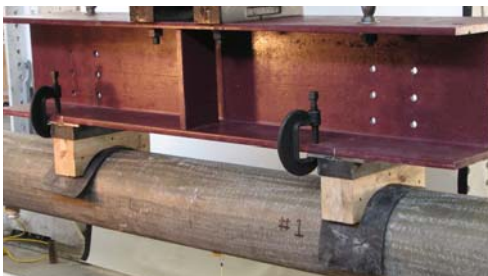
Bending test setup & actuator for the SeaShield Series 400.

Test Setup: Six each 8" diameter x 16' long timber piles were tested in bending using a four point bending setup. To simulate deterioration, five of the piles had an hourglass-shaped cut into them at mid-span. One specimen was left undamaged which was used as a baseline control specimen.

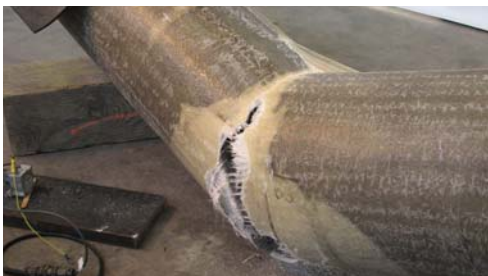
Completed bending test – all piles doubled in strength compared to the original unprotected piles.

Results: The results of the six pile bending tests proved that all repaired piles exceeded the bending strength of the baseline pile by at least double the maximum load achieved by the baseline pile.

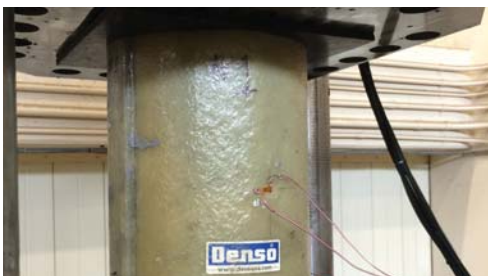
Compressive test setup.

Test Setup: Four each 8" diameter x 20" long timber piles with a fiberglass reinforced jackets, grout and carbon fiber grid. One specimen was a plain timber pile with no repairs and used as a baseline control pile. The objective was to evaluate the behavior of the repairs and quantify the additional compressive strength from the repairs vs. the baseline control specimen.

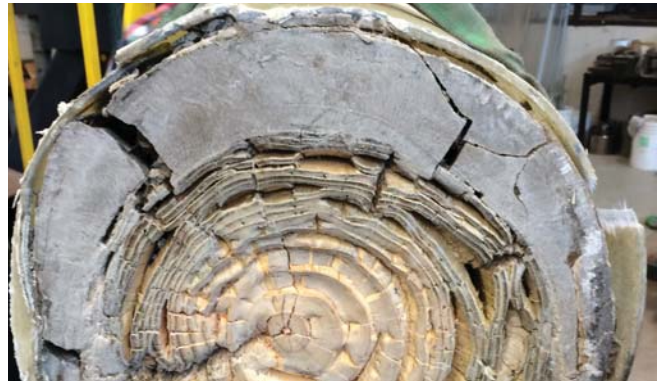
All specimens withstood 3 to 4 times the failure load of the baseline control specimen.

Results: The compressive failure loads of all four pile specimens were significantly higher compared to the baseline control specimen. The average increase in the axial compressive strength was approximately 240%. All specimens withstood 3 to 4 times the failure load of the baseline control specimen.

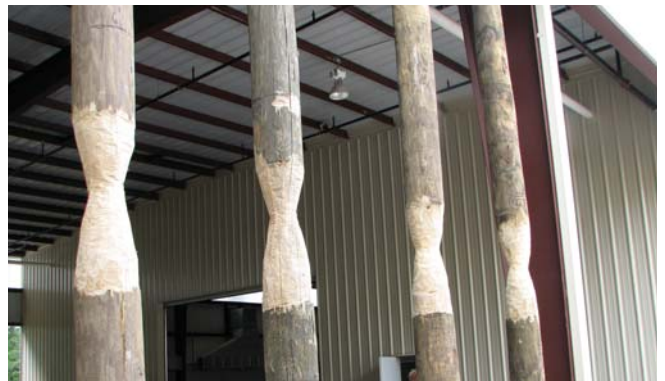
Simulated timber pile hourglass deterioration prior to having the SeaShield Series 400 System installed.

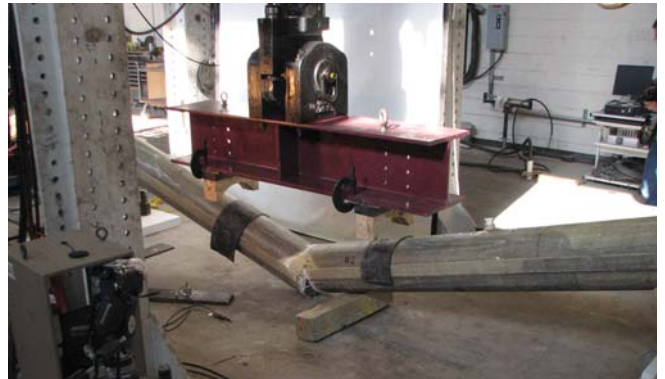
SeaShield Series 400 System at least doubles the maximum load than an undamaged, unprotected timber pile.

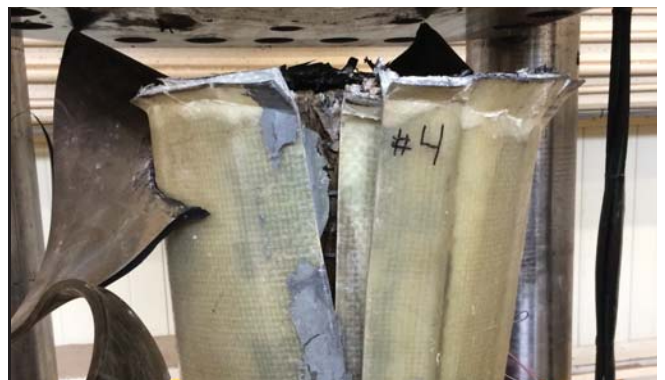
Timber piles installed with the SeaShield Series 400 System were able to withstand a maximum compressive pressure up to 466.6 kips.
