### Project Data

Location	Tupman, California
Completed	2017
Project Type	Hot Pipe Coating
Products / Systems Used	Archco 400 / Archco 453HT
Contractor or Applied By	Maintenance Personnel

### Project Details

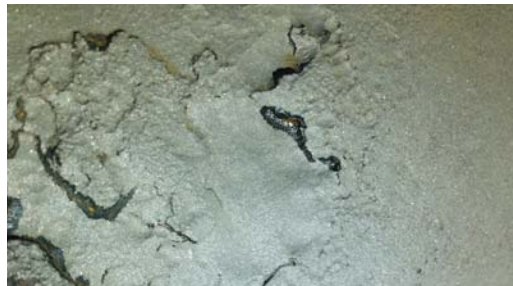
Severe corrosion and pitting was discovered when tape was removed, and the pipe was sand blasted.

An oil producer in California has had issues with their hot lines leaking into the producing oil and gas fields. After digging up the buried lines, they observed that the asphalt tape system, applied to the lines, had failed resulting in serious corrosion.

The engineer in charge of this project did not want to go back with the tape system. They preferred a coating that would take temperatures anywhere from 90°F to 250°F. They had looked at other coatings, but most of the coatings they tried would not hold up to the higher temperatures and the content of H<sub>2</sub>S in the soil. Having some past experience with the 453HT at higher temperatures, Denso recommended the 453HT for this high heat, and resistant to H<sub>2</sub>S service. The 453HT was applied in one pass at 30 mils DFT.

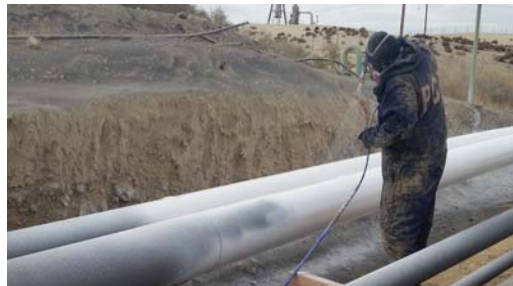
Archco 453HT being sprayed applied out in the field.

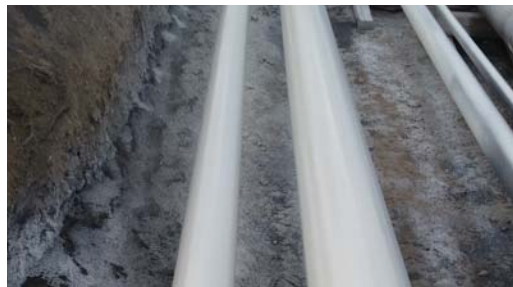
Fully cured Archco 453HT is an excellent heat resistant coating for the petrolatum industry.
