### Project Data

<b>Location</b>	Houston TX
<b>Completed</b>	2017
<b>Project Type</b>	Seal Heavily Pitted Floor from Ring Out with Holidays.
<b>Products / Systems Used</b>	Archco™ 401

### Project Details

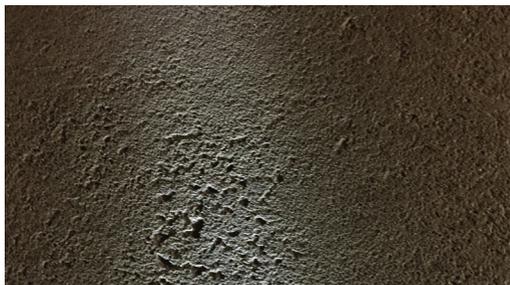
Heavy pitted floor.

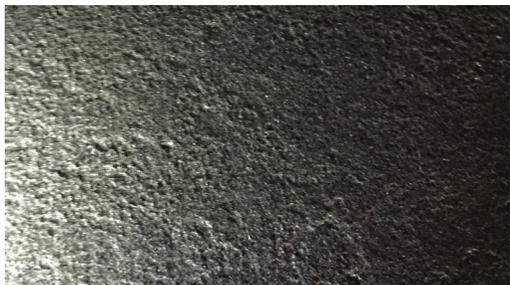
Heavy pitted floor with 401 sealer.

By using the 401 sealer, designed to have low viscosity, the coating would penetrate into the pit, and completely seal and fill the pit. Most viscous primers have a tendency to bridge over the pit. The trapped air in the pit keeps the coating from penetrating down to the bottom, and from sealing the pit. If the coating does not allow the air bubble to escape the pit, then the air is sealed over, which in turn allows the voltage of the holiday detector to penetrate through the coating film to the void and ring out as a holiday.

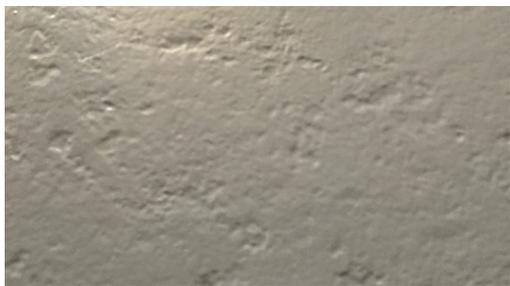
Heavy pitted floor with 401/476 pinhole free.
