### Project Data

Location	Houston TX
Completed	2017
Project Type	Seal Heavily Pitted Floor from Ring Out with Holidays.
Products / Systems Used	Archco 401

### Project Details

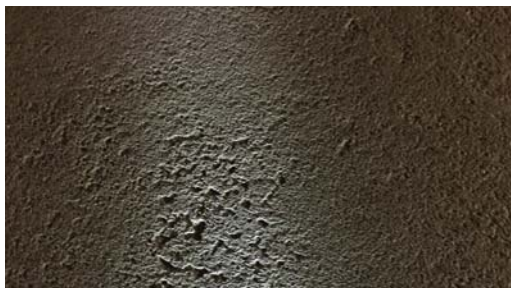
Heavy pitted floor.

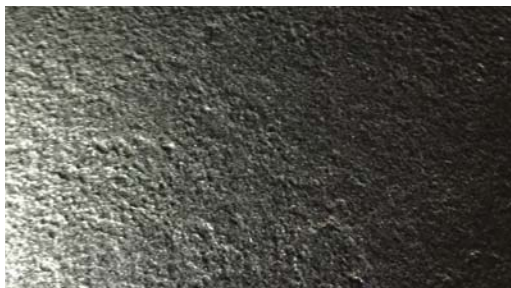
Heavy pitted floor with 401 sealer.

By using the 401 sealer, designed to have low viscosity, the coating would penetrate into the pit, and completely seal and fill the pit. Most viscous primers have a tendency to bridge over the pit. The trapped air in the pit keeps the coating from penetrating down to the bottom, and from sealing the pit. If the coating does not allow the air bubble to escape the pit, then the air is sealed over, which in turn allows the voltage of the holiday detector to penetrate through the coating film to the void and ring out as a holiday.

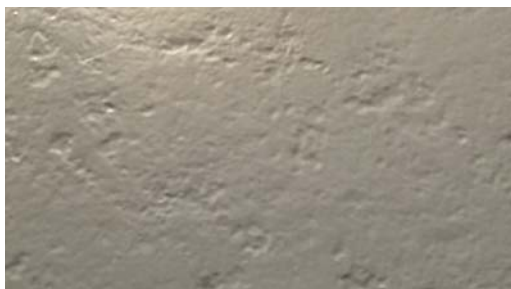
Heavy pitted floor with 401/476 pinhole free.

The major concern with the bottom of the pits not being sealed is when the tank is put back into service, moisture in the tank will permeate the coating film and fill the bottom with moisture, which in turn, creates a corrosion cell and penetrates through the steel plate, creating a leak. The 401 with the top coat will seal the steel surface, not allowing vapor to penetrate into the void and create a corrosion cell.
