Project Data

Location	Albany, New York
Est. Completion	2016
Project Type	Tank Rehabilitation Coating
Products / Systems Used	Archco 400 / Archco 476F
Contractor or Applied By	Maintenance Personnel

Project Details

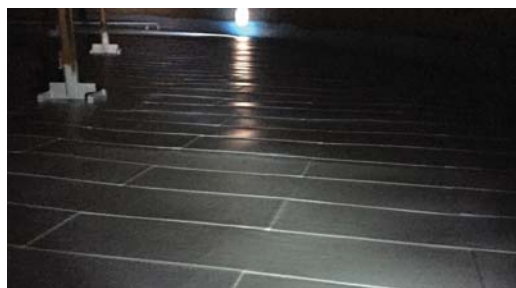
Pipeline storage company, 220' fuel oil tank, outside Albany, New York, on the Hudson River.

A large pipeline company wanted a system that would allow them keep their existing floor for another 10 to 20 years instead of replacing it. It was decided to sweep -blast the existing lining and apply rehabilitation coat, instead of removing it.

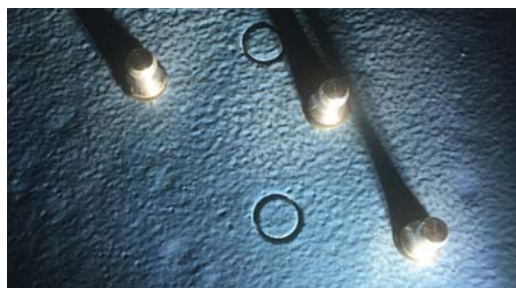
Adhesion test, 2500 psi to 2800 psi

The 400/476F was recommended for this project for this reason. The 400 primer/sealer bites into the swept blasted existing coating, creating an excellent bond to anchor the 476F. The 476F was then applied over the 400 primer at 30 to 35 mils dft in one coat. The 476F sprays and builds very well creating an epoxy reinforced glass barrier system. The 476F is an epoxy phenolic epoxy that is very chemical resistant, has good heat resistance and has good abrasion resistance. After the lining was cured, adhesion tests were performed to check the mechanical and chemical bond to the existing substrate. The readings were anywhere from 2300 psi to 2800 psi. The owners can expect the lining service life to meet their needs.

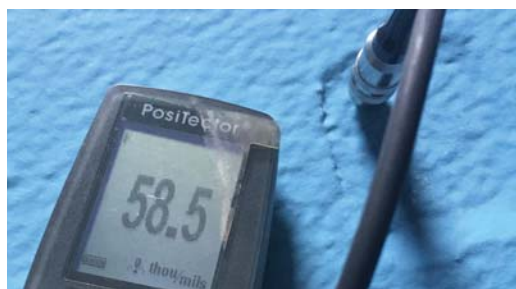
System 400 primer @ 4 to 5 mils dft, 30 to 35 mils dft of 476F single leg.
