### Project Data

Location	Albany, New York
Est. Completion	2016
Project Type	Tank Rehabilitation Coating
Products / Systems Used	Archco 400 / Archco 476F
Contractor or Applied By	Maintenance Personnel

### Project Details

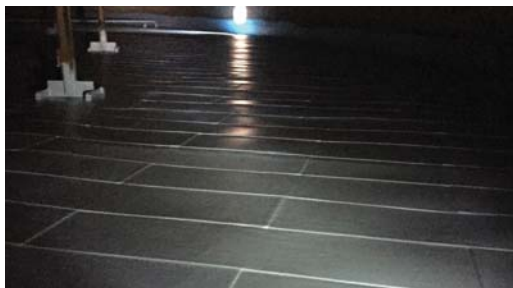
Pipeline storage company, 220' fuel oil tank, outside Albany, New York, on the Hudson River.

A large pipeline company wanted a system that would allow them keep their existing floor for another 10 to 20 years instead of replacing it. It was decided to sweep -blast the existing lining and apply rehabilitation coat, instead of removing it.

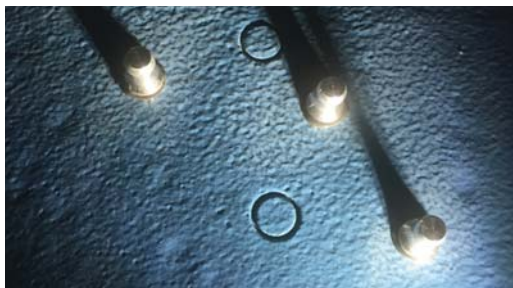
Adhesion test, 2500 psi to 2800 psi

The 400/476F was recommended for this project for this reason. The 400 primer/sealer bites into the swept blasted existing coating, creating an excellent bond to anchor the 476F. The 476F was then applied over the 400 primer at 30 to 35 mils dft in one coat. The 476F sprays and builds very well creating an epoxy reinforced glass barrier system. The 476F is an epoxy phenolic epoxy that is very chemical resistant, has good heat resistance and has good abrasion resistance. After the lining was cured, adhesion tests were performed to check the mechanical and chemical bond to the existing substrate. The readings were anywhere from 2300 psi to 2800 psi. The owners can expect the lining service life to meet their needs.

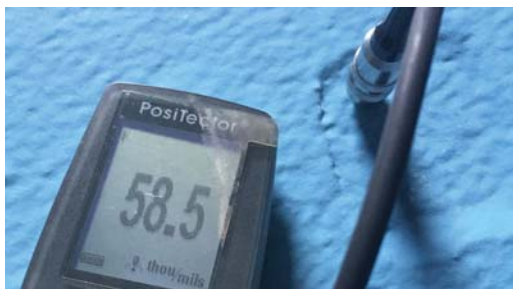
System 400 primer @ 4 to 5 mils dft, 30 to 35 mils dft of 476F single leg.
