Project Data

Location	Manhattan, NY
Completion	2002
Project Type	Timber Pile Protection
Products / Systems Used	Fiber-Form
Contractor or Applied By	Strongwork Diving

Pier 16 in Manhattan, NY is one of the city's most active tourist piers. It is adjacent to the Fulton Fish Market. In service for over 50 years, the timber piles have received marine borer damage, which threatened the structural integrity of the pier. This major rehabilitation called for more than 6,000 LF of timber pile repairs.

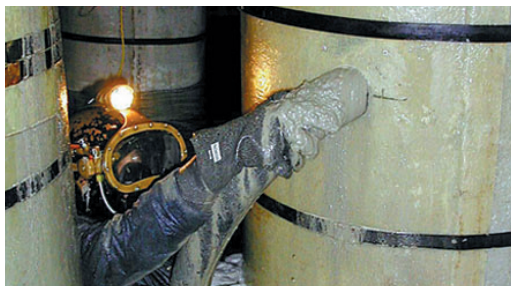
Concrete is pumped into the annulus space between the jacket and timber pile.

The timber piles that had received extensive damage from the marine borers received concrete encapsulation. The repair involved building a reinforcement cage around the piles and then installing the SeaShield Fiber-Form. The concrete was then pumped into the annulus space, which increased the overall strength of the pile. To provide ease of application the forms were fabricated in a translucent color to allow the contractor to view the concrete level during the pumping operation.

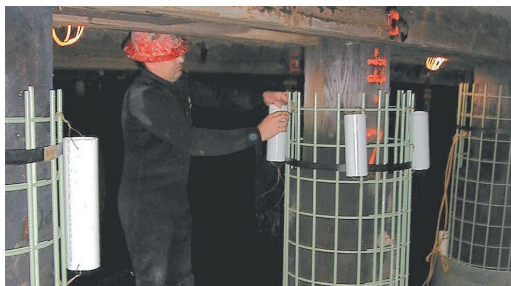
The SeaShield™ Fiber Forms are positioned around the timber piles.

The pile repair system chosen was a concrete encapsulation with fiberglass forms. The consultant, Han-Padron and New York City Economic Development Corporation approved Denso's SeaShield Fiber-Forms. The SeaShield Fiber-Forms (fiberglass jackets) are a custom fabricated fiberglass jacket with a tongue-and-groove closure. It provides a strong rigid form to allow concrete to be pumped into the annulus space between the jacket and timber pile.

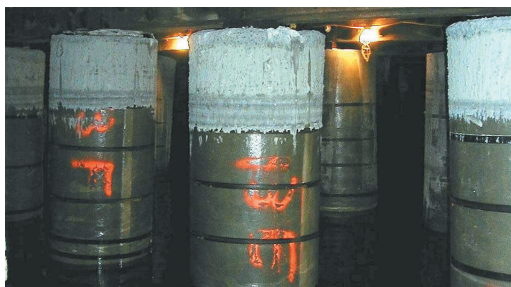
Completed SeaShield™ Fiber-Form system.
