### Project Data

Location	Tampa, FL
Completion	2011
Project Type	Dock Pile Rehabilitation
Products Used	SeaShield Series 2000HD System
Contractor or Applied By	Misener Marine

### Project Details

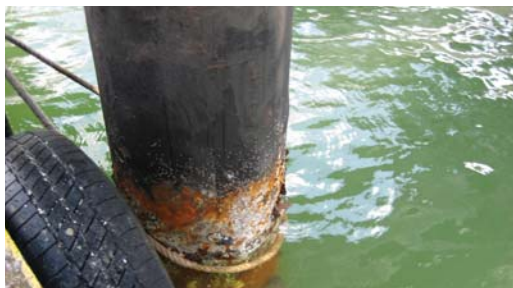
Severe corrosion of pile prior to cleaning.

The severe blistering and peeling was along the full length of the piles and consisted of 89 each 24" diameter x 35 feet. Misener Marine was selected as the dive contractor to install the Series 2000HD System. To clean the piles and install the system they utilized two dive stations from a flat bottom dive boat. The piles were cleaned to a SSPC SP 2-3. Next the Denso S105 was applied over the entire surface to be coated. Then, the Denso Marine Piling Tape was applied with a 55% overlap. Misener Marine used 2 divers for the underwater portion which took less than one hour, per pile, to wrap each 35' pile. The last step of the installation was to apply the heavy-duty HDPE outer covers, which were secured with 316 stainless steel bolts and nuts.

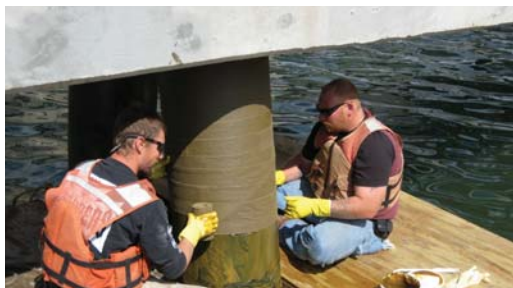
Wrapping the prepared pile with Denso Marine Piling Tape.

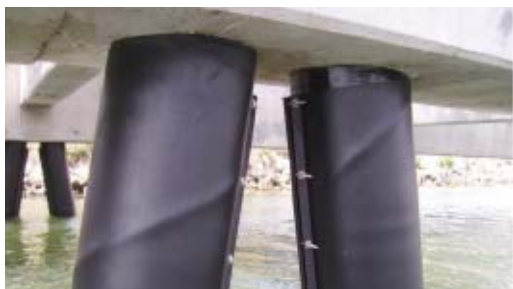
Pile protected from with Denso's SeaShield Series 2000HD.
