Project Data

Location	Victoria, TX
Completion	August 2015
Project Type	Tank Base Protection System
Products Used	Densyl Mastic / Hi-Tack Tape / FB 30 Tape / Denso Weathershield 55
Contractor or Applied By	Maintenance Personnel

Project Details

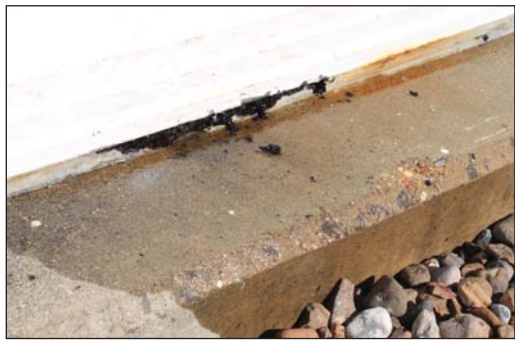
Tank caulk used as a sealant has a tendency to crack and absorb water over time.

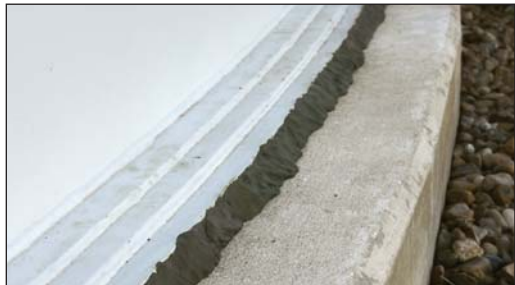
Tank plinth area seal with Densyl Mastic to prevent moisture from entering.

After the surface was prepared, the tank plinth was filled in with Densyl Mastic by hand rolling into thin strips and sealing the gap between the tank and concrete base. The mastic provided a smooth profile when applying the Denso Hi-Tack Tape, a high adhesive anti-corrosive petrolatum tape. The Hi-Tack Tape was simply cut into 2-3' sections, which made for an easier application, and applied circumferentially around the tank base maintaining a minimum 1" overlap onto the concrete base and steel tank. Next, the Denso FB 30 Tape, a butyl rubber tape with a fabric backing, was applied circumferentially maintaining a minimum 1" overlap past the Hi-Tack Tape onto the concrete base and steel tank. The last step was the Denso Weathershield 55, a high build flexible acrylic top coat, which was brush applied over the FB 30 Tape for UV protection.

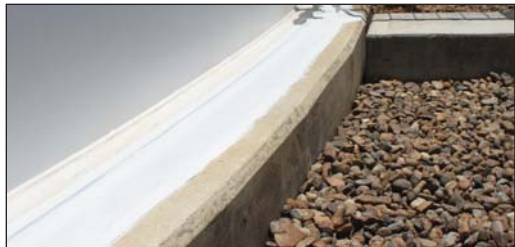
Finished tank with Denso Weathershield 55 applied as a top coat completing the system.
