SeaShield Marine Systems

Series 90

Timber pile protection system that includes petrolatum tape and a protective outercover

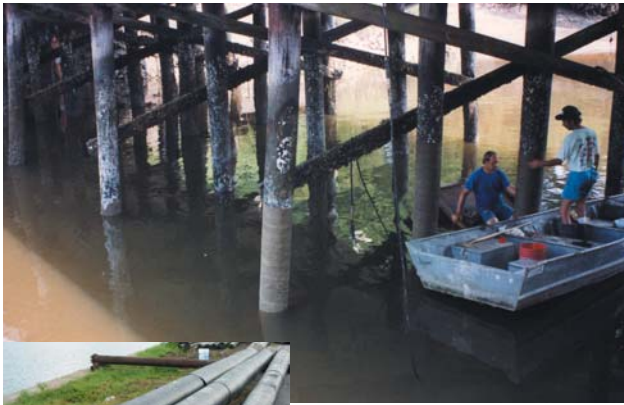
SeaShield Series 90 consists of Denso Marine Piling Tape preventing marine borer destruction and an outcover for mechanical protection of tape.

The Series 90 System utilizes the proven Denso Marine Piling Tape for eliminating oxygen from reaching the pile and is highly conformable to all shapes and irregularities of the pile. The outcover is used for mechanical protection of the tape. No seals are required on the outcover, thus eliminating the need for a tight seal of the jacket.

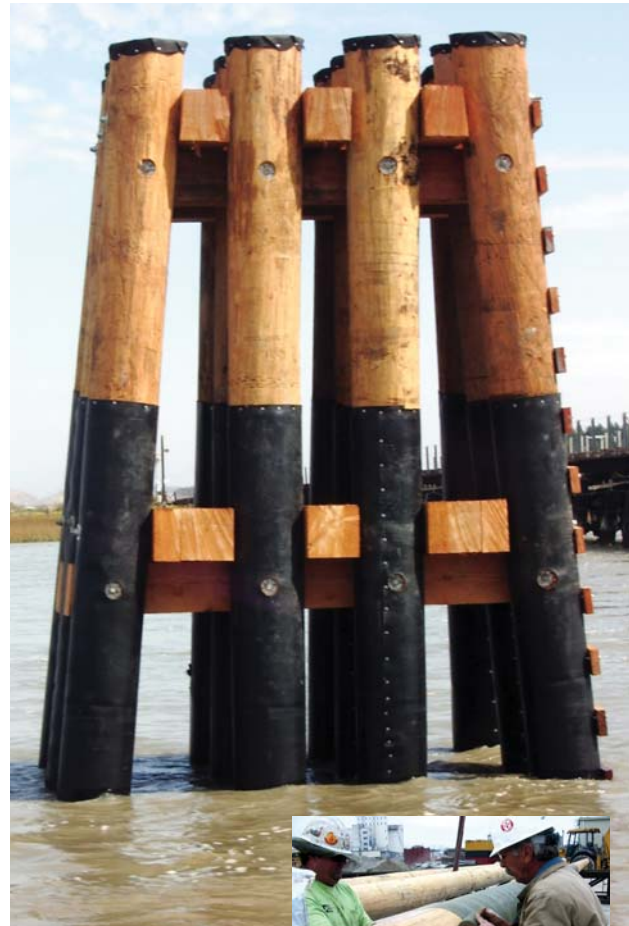
SeaShield Series 90 System

The Series 90 System can accommodate hour-glassed piles, posting, bracing and other timber support members. This system is easily installed and does not require any special or expensive equipment. It is the most effective, economical and long-term solution to extending the life of new or existing timber piles.
