DENSO DIGEST

Volume 38, Number 1

Groundbreaking Advances in Offshore Pipelay: Denso's Viscotaq™ Offshore Field Joint Coating System

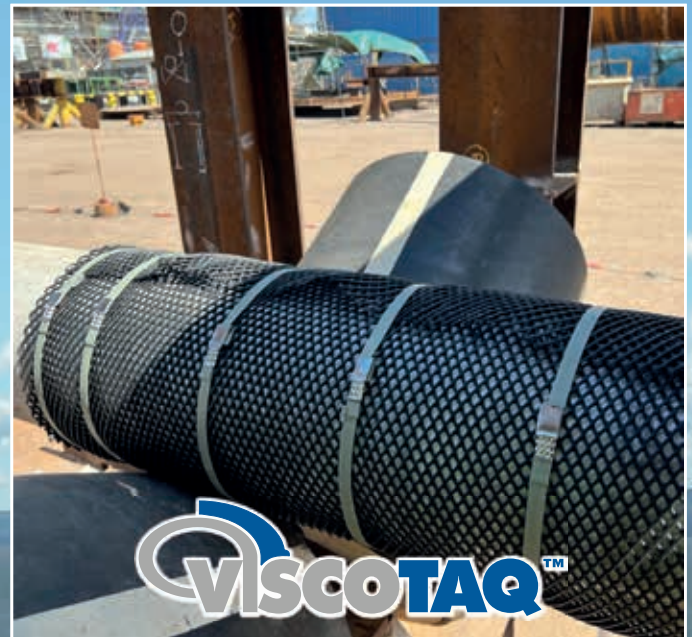
Roller box test simulating the pipelay vessel's stringer operation.

In addition to the PQT, the OIC required Roller Box Testing to be completed. The Viscotaq OFJC system was subjected to a 10-tonne load roller/stinger simulation. This testing was completed during the Pre-Production Test (PPT) stages at the OIC's yard. The Viscotaq OFJC system met all requirements of the Roller Box and PPT.

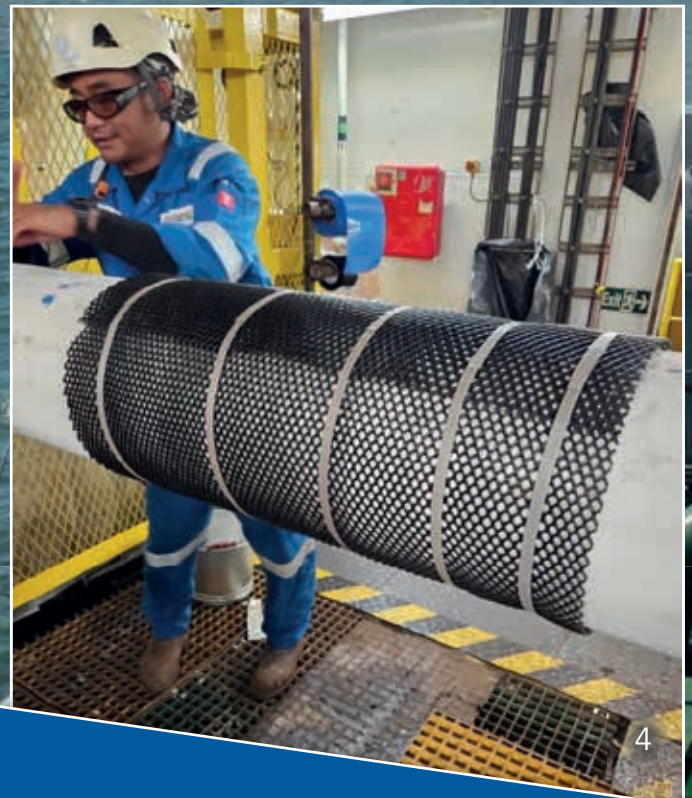
A completed FJC application ready to be placed into the sea.

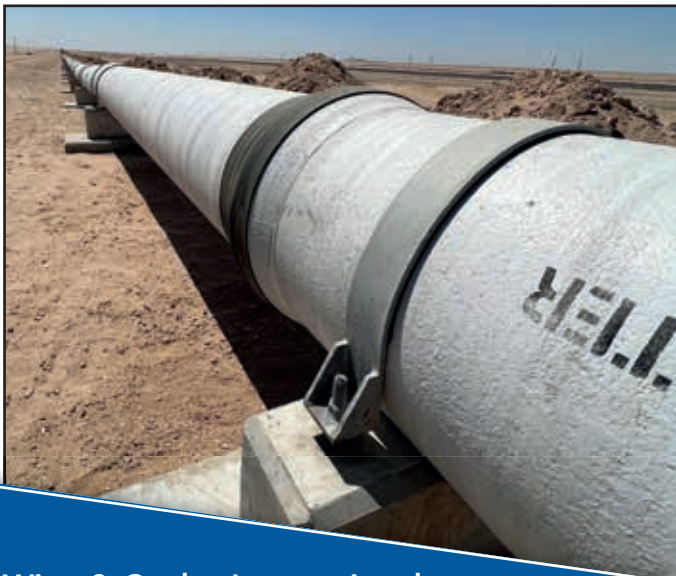
Above ground pipe with threaded round bar and strapping securing pipe.

Denso were asked to provide a solution to protect threaded bars which are used to secure an above ground pipeline of roughly 23km which consists of 3893 pedestals and 7786 threaded round bars.

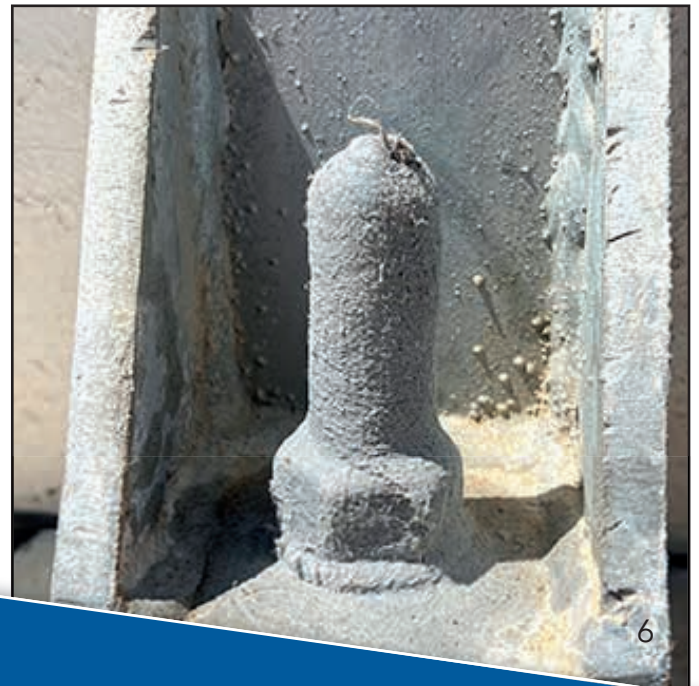
Steelcoat™ ColourTape applied to M20 threaded rounded bars/nuts.

Denso proposed and trialled the Steelcoat™ ColourTape in the presence of the client, consultant and contractor in October 2021 and, after three months of subjecting the ColourTape to the harsh environments of Namibia, it was removed from the threaded bars to reveal a corrosion-free bar.

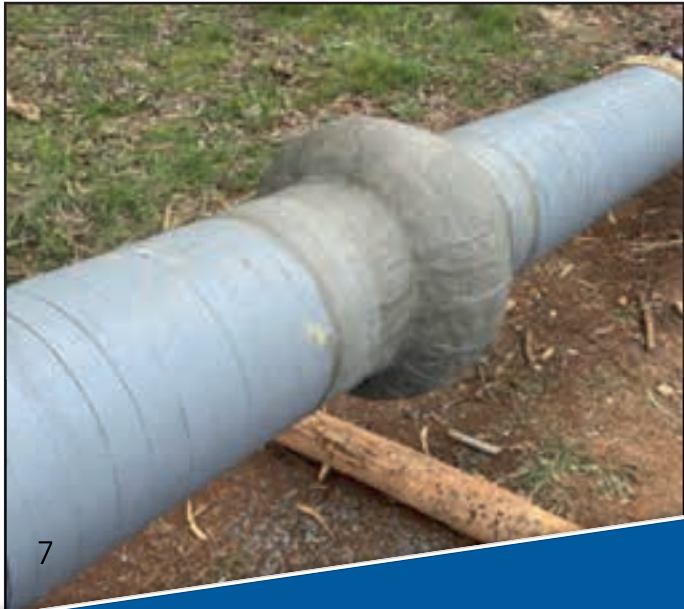
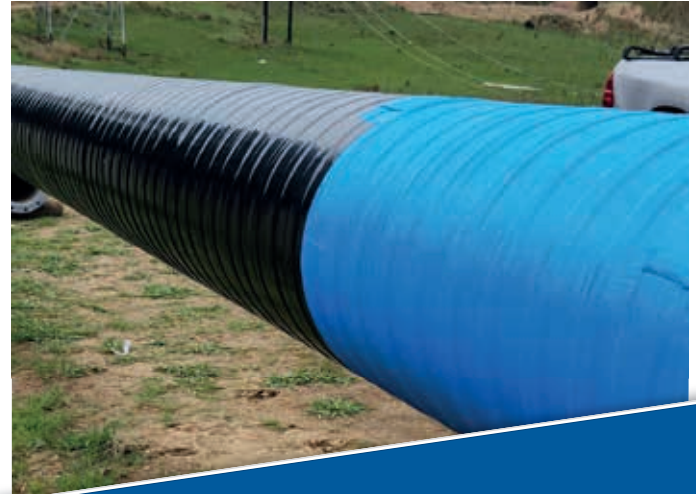
Denso ViscoWrap™ ST and Denso™ PVC HD applied to a length of pipe as part of a trial section.

The client also requested an on-site demonstration of Denso ViscoWrap™ ST and Denso™ PVC HD which was carried out on a 12m section of pipe.

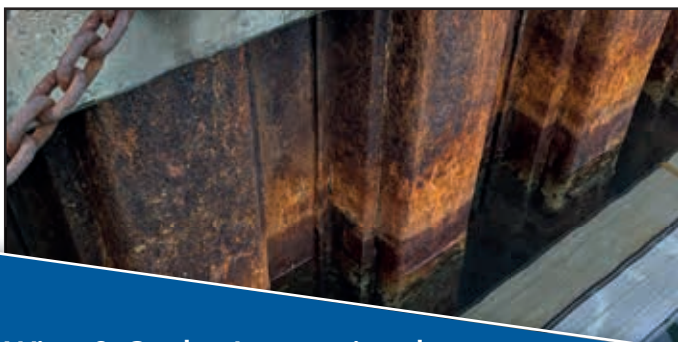
Below: Sheet pile wall before the SeaShield application.

The sheet pile wall on Rottnest Island was constructed in stages beginning in the 1960s and has suffered severe corrosion in the splash zone over that time. The *SeaShield 2020SP™ System was selected to prevent further corrosion and provide a life extension to the structure.

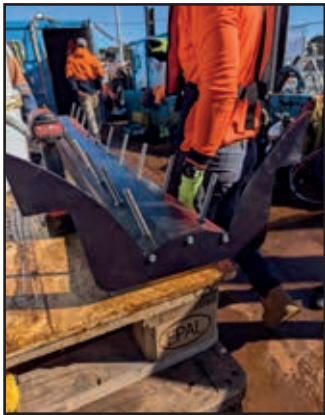
Wall attachment spine.

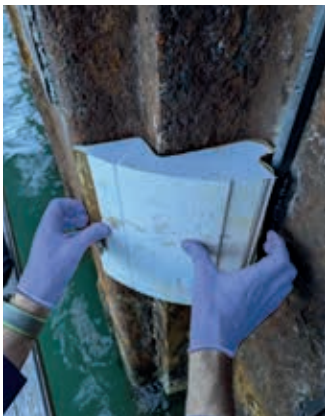
Application of Foam Filler.

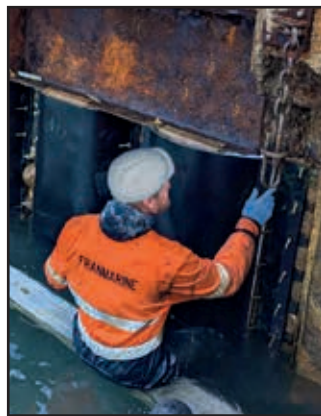
Installation of HDPE Jackets.

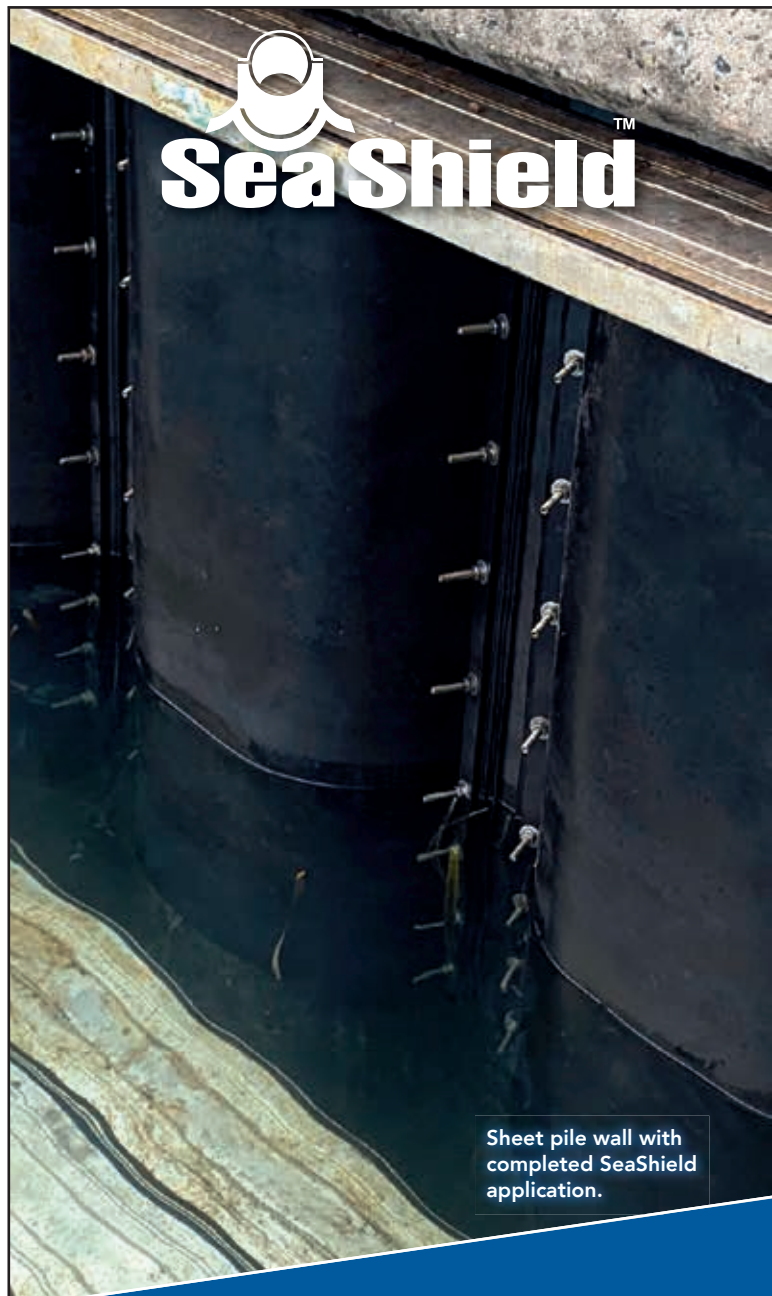
Sheet pile wall with completed SeaShield application.

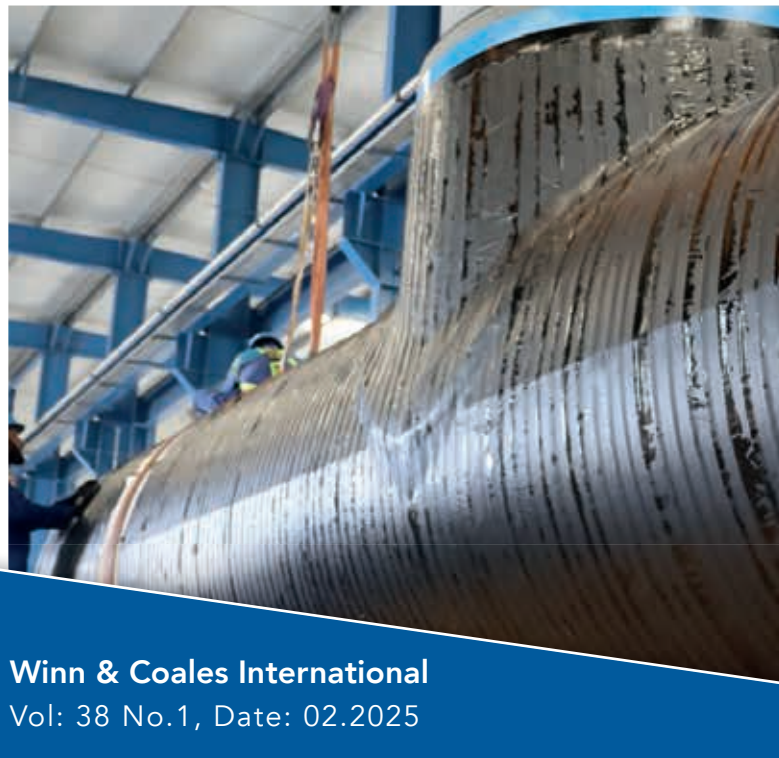
After priming with Denso Primer D, the initial wrap of Densopol 80HT is applied.

In this specific instance the training covered the long-term protection of below ground buried DN1,400 to DN1,800mm diameter FBE coated carbon steel pipe fittings with a maximum peak operating temperature of 75°C. The Denso products demonstrated were Primer D, Densopol 80HT Tape and Denso PVC SA 200 Yellow Tape.

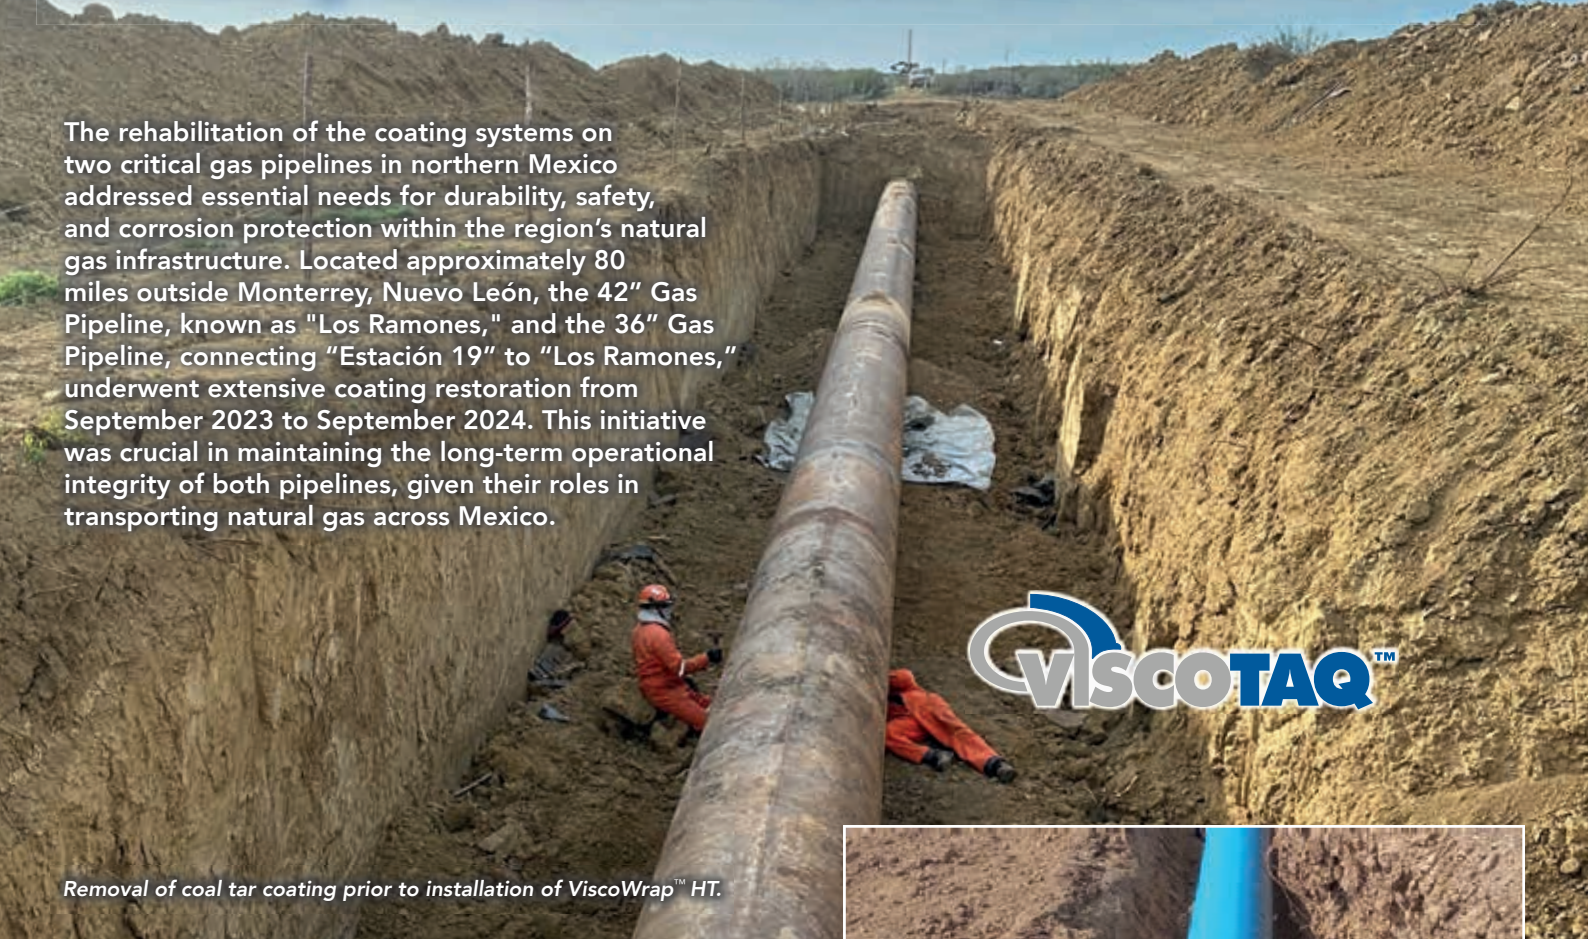
Removal of coal tar coating prior to installation of ViscoWrap™ HT.

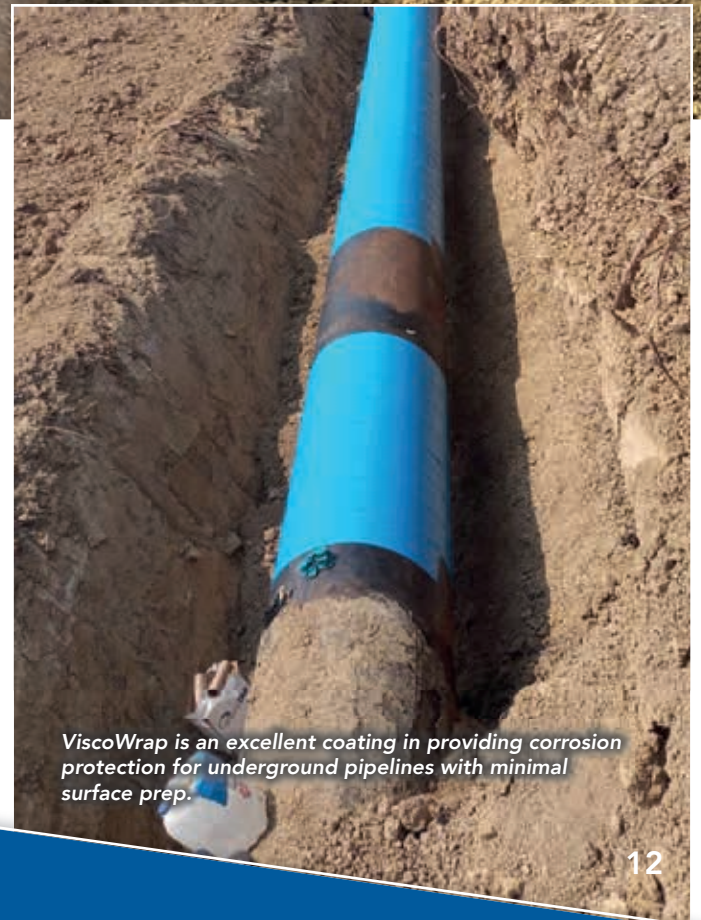
ViscoWrap is an excellent coating in providing corrosion protection for underground pipelines with minimal surface prep.

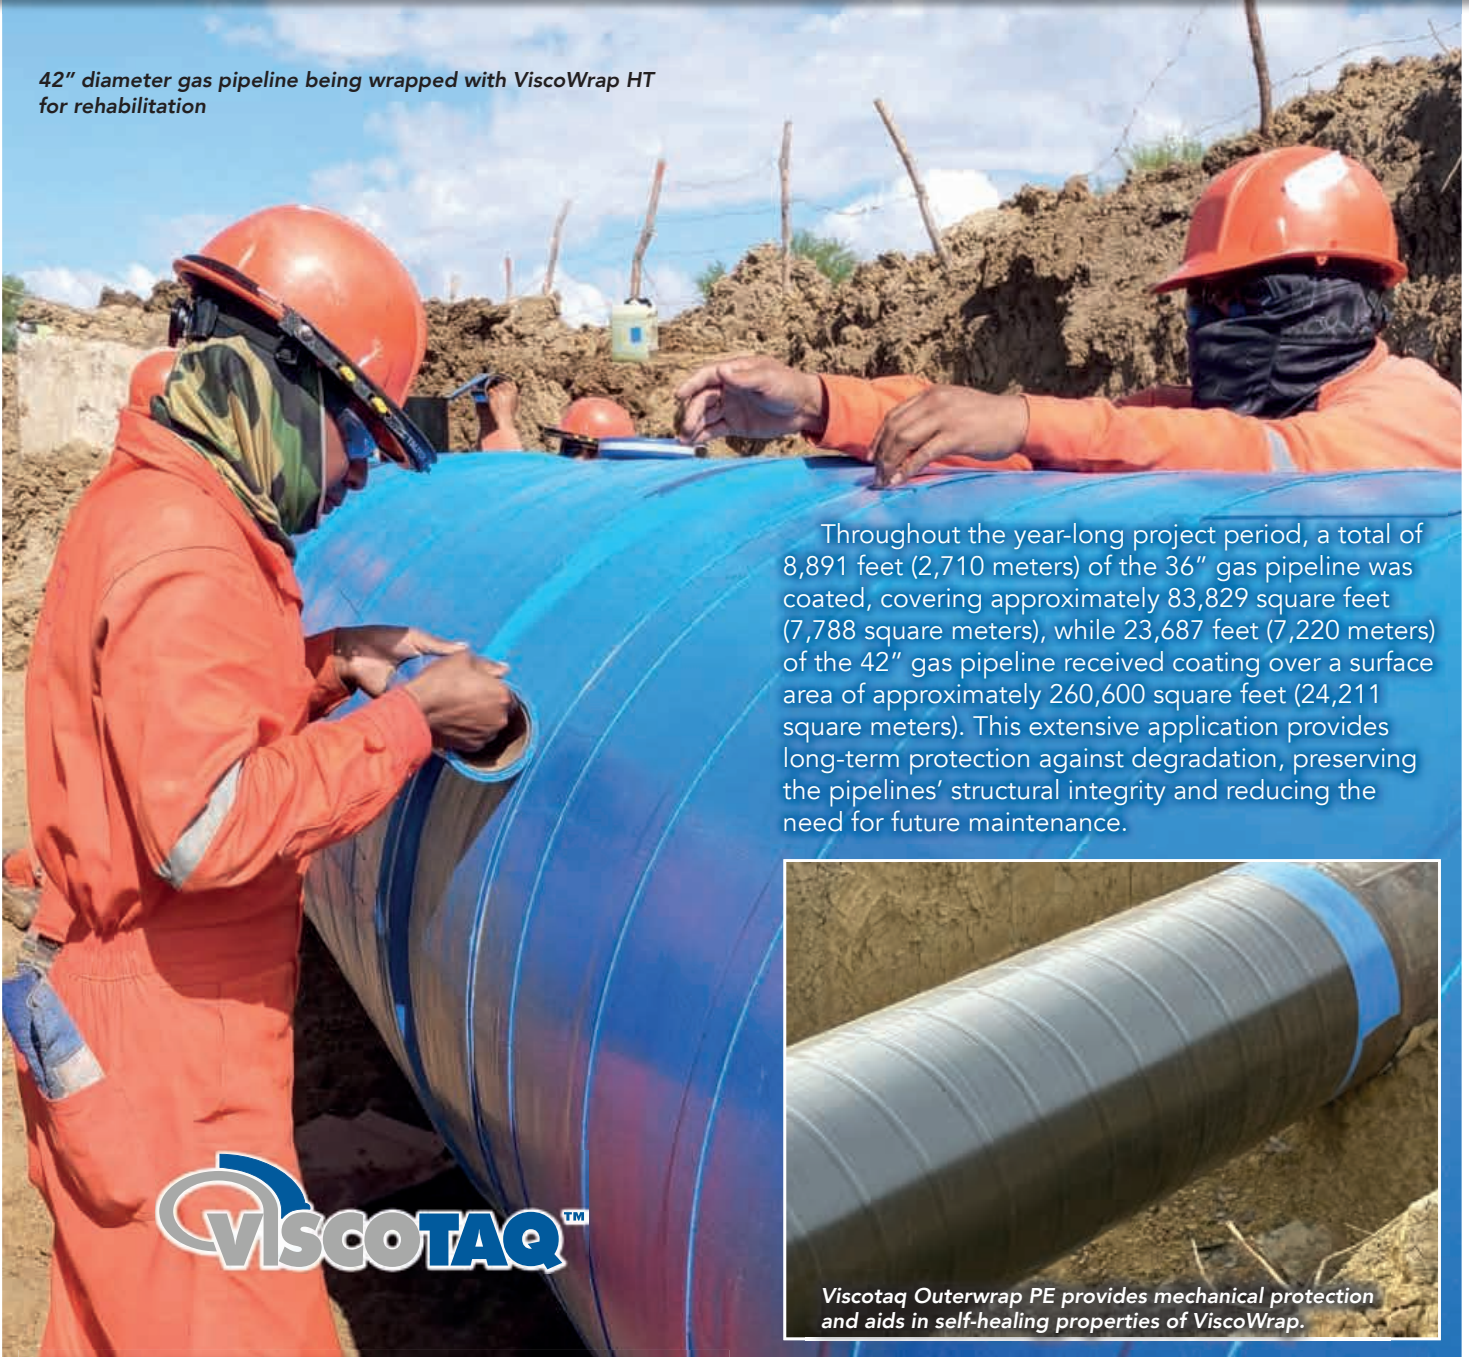
42" diameter gas pipeline being wrapped with ViscoWrap HT for rehabilitation

The rehabilitation work involved the application of advanced coating solutions designed to withstand Mexico's demanding environmental conditions. The coating system used included ViscoWrap™ HT (12" x 33') with an outer layer of Viscotaq™ Outerwrap PE (6" x 100'), a configuration selected for its robust corrosion protection capabilities. On suitably prepared surfaces the unique visco-elastic properties of ViscoWrap HT allow it to bond rapidly to substrates without priming, offering exceptional resilience against corrosion without the need for primer or abrasive blast cleaning to a high standard. Additionally, its self-healing nature makes it resistant to harsh soil conditions, ensuring the pipelines are better protected against potential damage and corrosion in the future. The result is a durable, low-maintenance solution that reduces operational costs while enhancing pipeline safety and longevity.

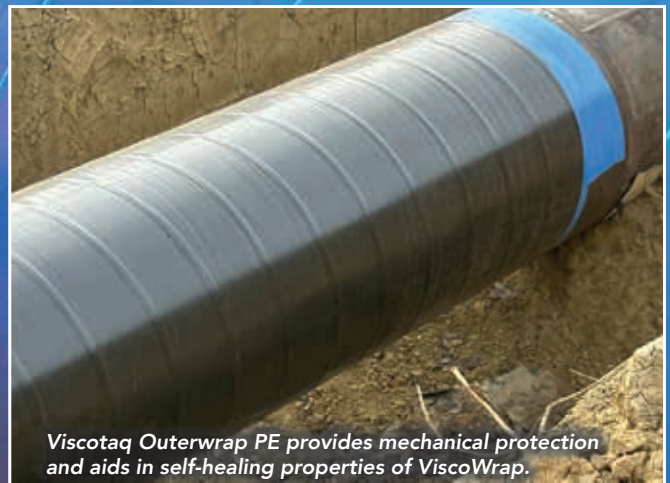
Viscotag Outerwrap PE provides mechanical protection and aids in self-healing properties of ViscoWrap.
